# **Sewer Line Inspection Report**

Danny TestVid  
1234 Green Street, St. Albert, AB

Date of Inspection: 2026-10-03

Job Number: 001

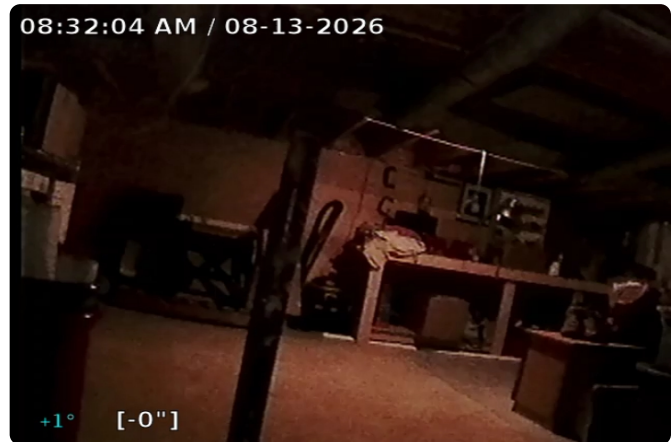
Video location: 0:15

| <b>Drain Type</b> | Sanitary |
| <b>Pipe Dirn</b> | Front of home |
| <b>Access Loc</b> | Base Utility |
| <b>Access Type</b> | Sewer Stack |
| <b>Material</b> | PVC |
| <b>Pipe Size</b> | 3" / 75mm |

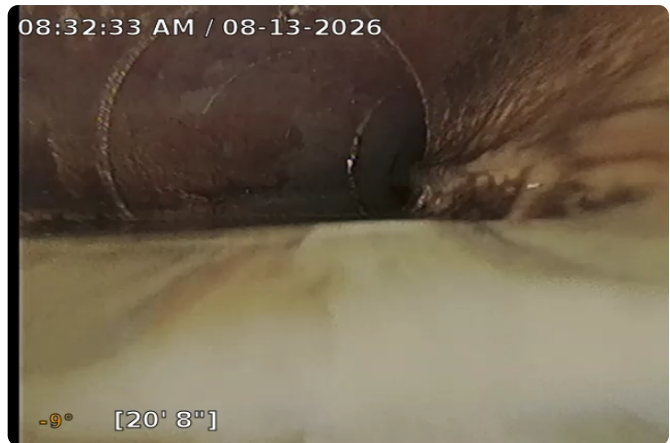
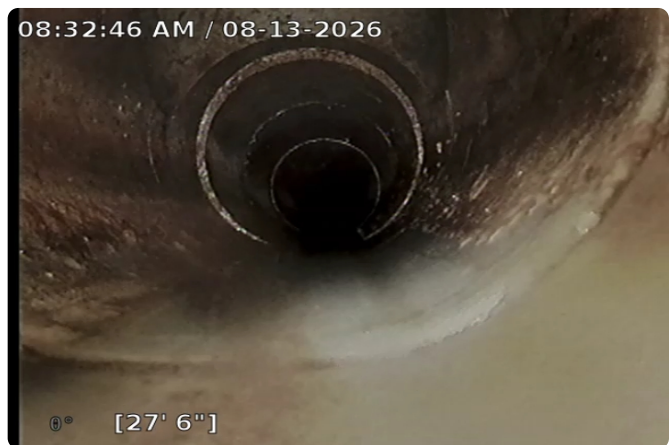
| Severity | Med |
| Defect | Sag |
| Dimensions | 6-10' long, 1" deep |
| Recommendation | Sag Repair |

Trench based repair. The drain line in proximity to the identified sag is dug up and the grade is repaired to ensure proper drainage slope. Pipe repairs/replacements may also be completed.

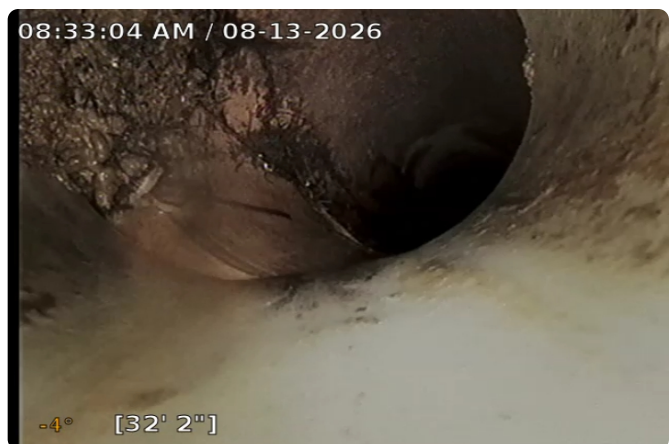
Video location: 1:15

| Type | Transition |
| Transition Type | Foundation Edge |
| Material | Clay |
| Size | 4" / 100mm |

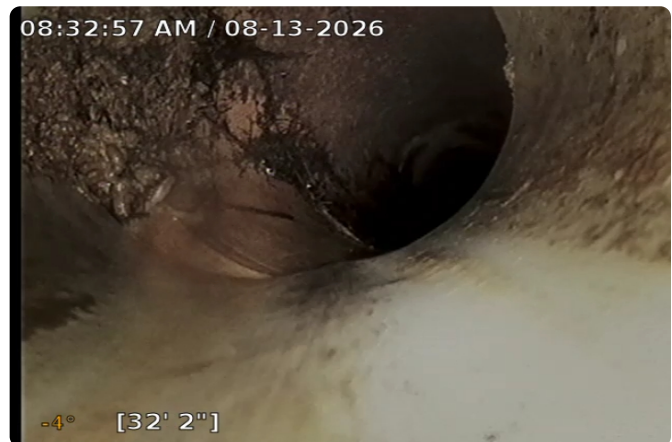
Video location: 1:08

| Severity | Low |
| Defect | Roots |
| Restriction | 0 % |
| Recommendation | Drain Cleaning |

Mechanical process used to remove roots, debris or other blockages and restrictions that do not require more invasive repairs.

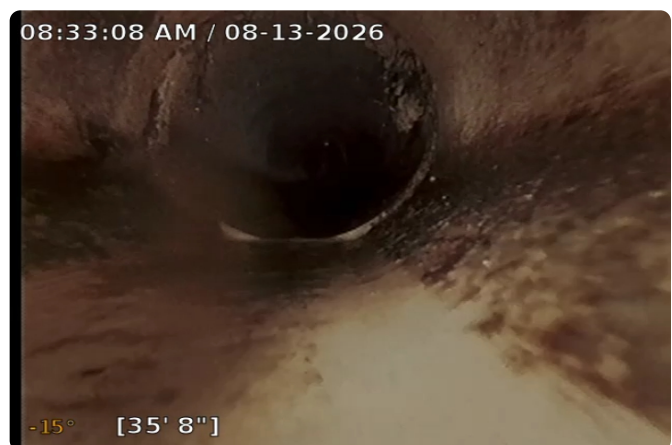
Video location: 1:19

| Severity | Low |
| Defect | Roots * |
| Restriction | 0 % |
| Recommendation | Drain Cleaning |

\* This is a representative example of the same defect observed at multiple locations in the drain system.

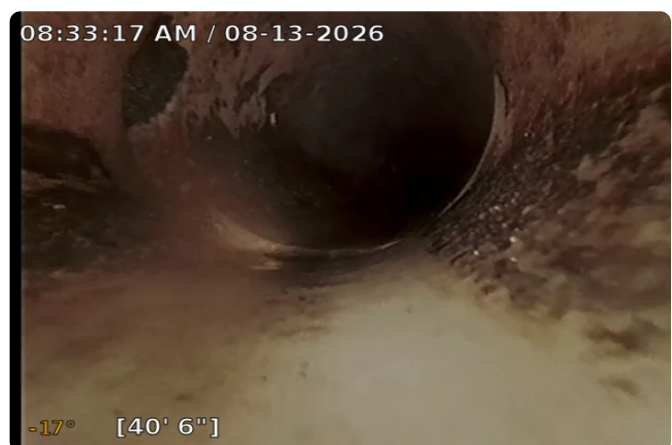
Video location: 1:28

| Severity | Low |
| Defect | Shift |
| Restriction | 0 % |
| Recommendation | Monitor |

Inspection of the drain with camera system to monitor the ongoing condition.

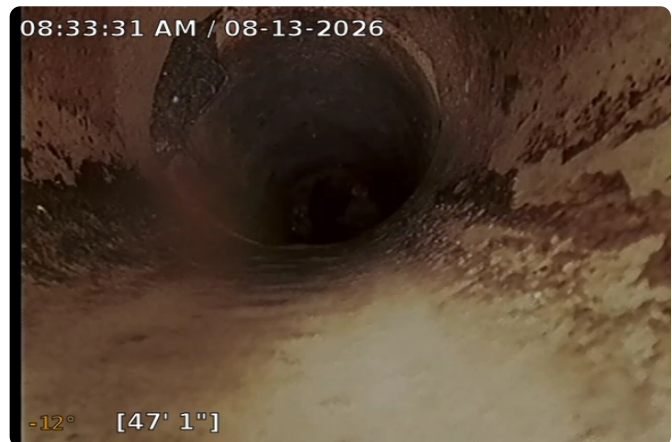
Video location: 1:42

| Severity | Low |
| Defect | Roots * |
| Restriction | 0 % |
| Recommendation | Drain Cleaning |

*\* This is a representative example of the same defect observed at multiple locations in the drain system.*

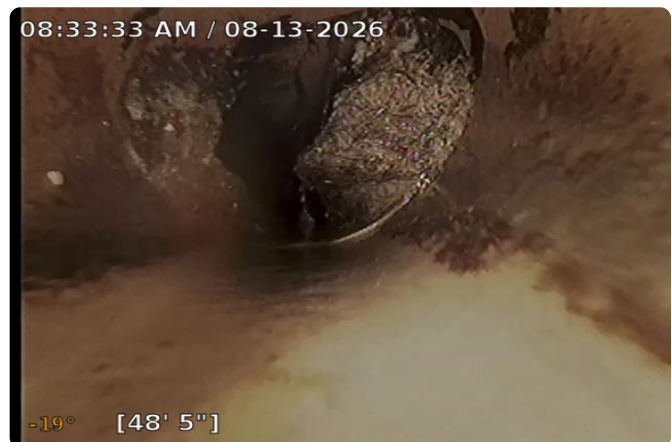
Video location: 1:44

| Severity | Med |
| Defect | Roots * |
| Restriction | 40 % |
| Recommendation | Drain Cleaning |

*\* This is a representative example of the same defect observed at multiple locations in the drain system.*

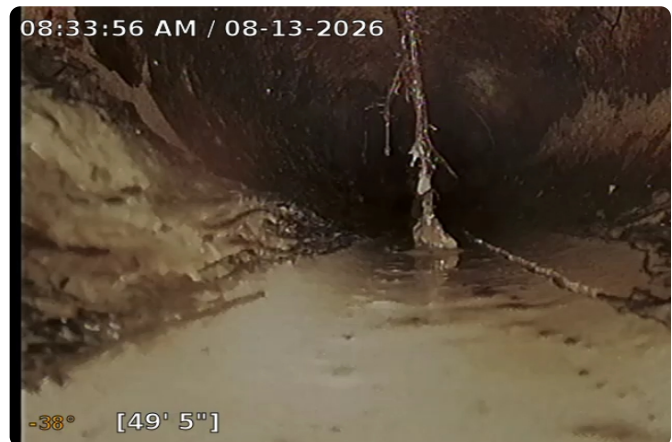
Video location: 2:07

| Severity | Med |
| Defect | Crack |
| Restriction | n/a |
| Recommendation | CIPP Liner |

No-dig repair operation that uses a cast in-place pipe process to replace a drain line with a polymer liner.

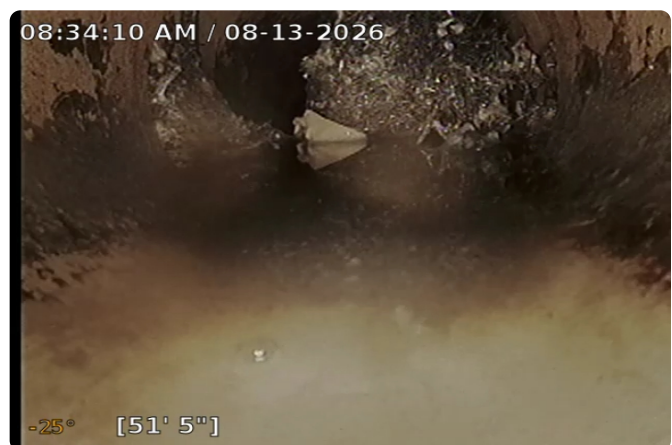
Video location: 2:21

| Severity | High |
| Defect | Roots * |
| Restriction | 60 % |
| Recommendation | Drain Cleaning |

\* This is a representative example of the same defect observed at multiple locations in the drain system.

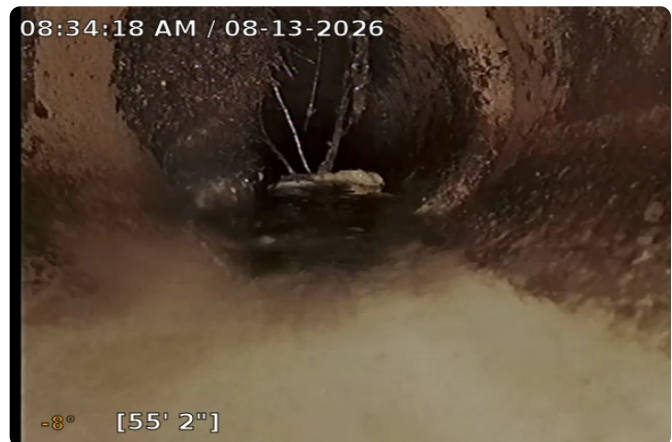
Video location: 2:29

| Severity | Med |
| Defect | Roots * |
| Restriction | 40 % |
| Recommendation | Drain Cleaning |

\* This is a representative example of the same defect observed at multiple locations in the drain system.

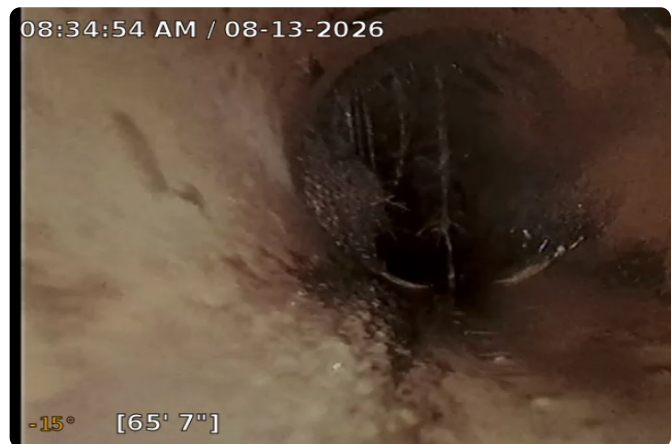
Video location: 3:05

| Severity | Med |
| Defect | Roots * |
| Restriction | 30 % |
| Recommendation | Drain Cleaning |

\* This is a representative example of the same defect observed at multiple locations in the drain system.
